CASE STUDY  
CHARCOT ARTHROPATHY

# REVOLUTION EXTERNAL PLATING SYSTEM | CHARCOT ARTHROPATHY CASE STUDY

INDICATION	Charcot Arthropathy**
CAUSE	Severe degeneration and dislocation of the rearfoot ankle
STRATEGY	Charcot Reconstruction with Static Frame Fixation
SURGERY DATE	06/07/2019

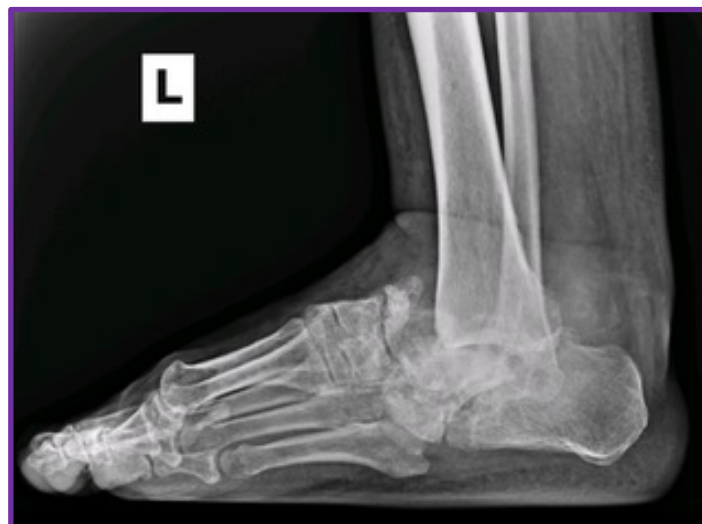
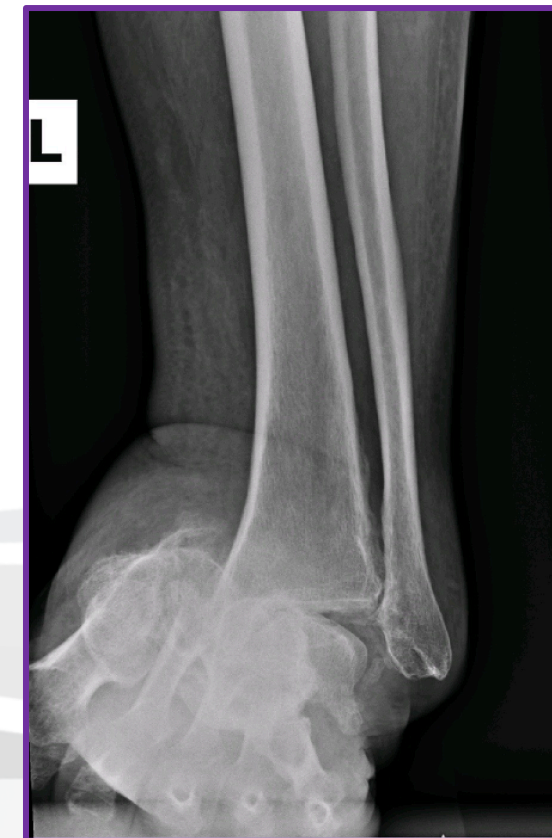
1

## PRE-OPERATIVE PHOTOS

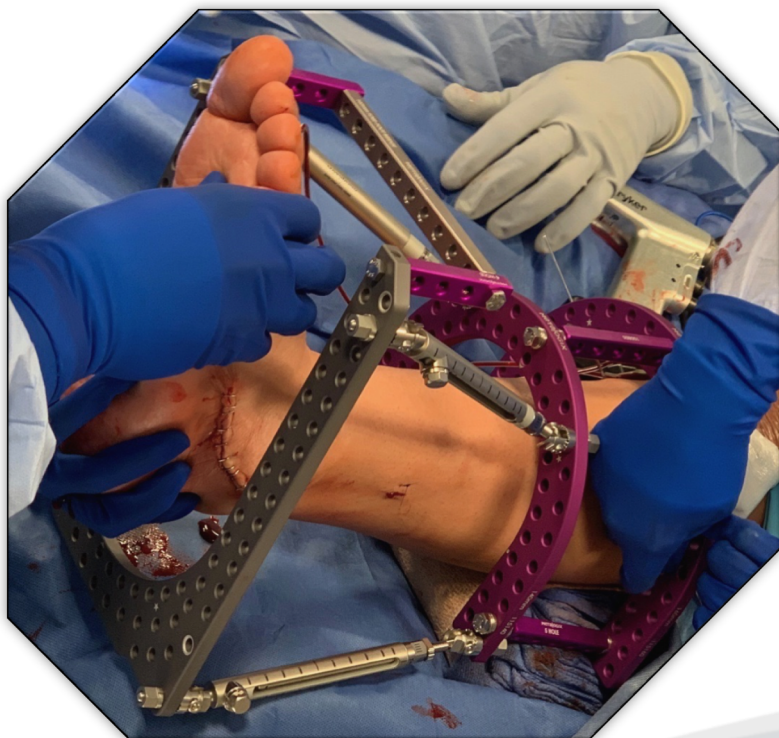
2

### SURGERY DETAILS

A pre-assembled frame was constructed prior to surgery. The tibial block had a 160mm n-Plate funneling down to a 140mm n-Plate all connected by three (3) 5-Hole Posts. The block had four (4) Long Super Struts connecting to a 140mm Footplate. The Footplate had a Bridge to close it off. The Bridge consisted of 4-Hole Posts and a 140mm Fore-Foot Bridge.

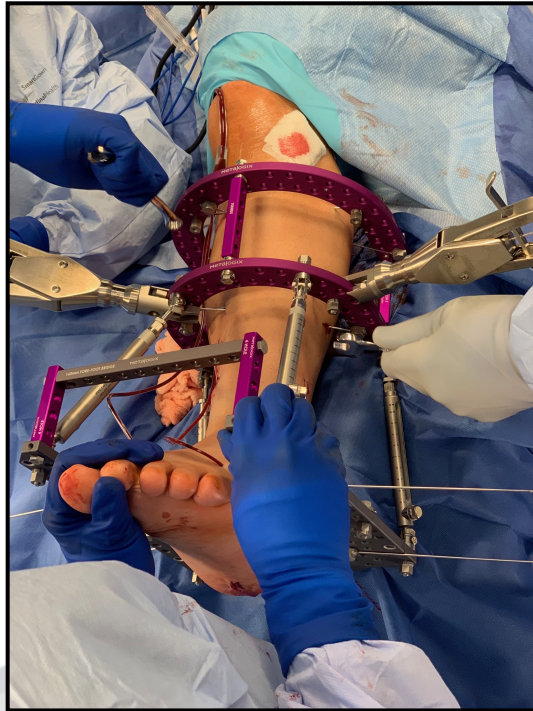
3

The first two (2) wires were inserted through the tibia to the proximal tibial block.\* The second two (2) wires were placed through the foot.

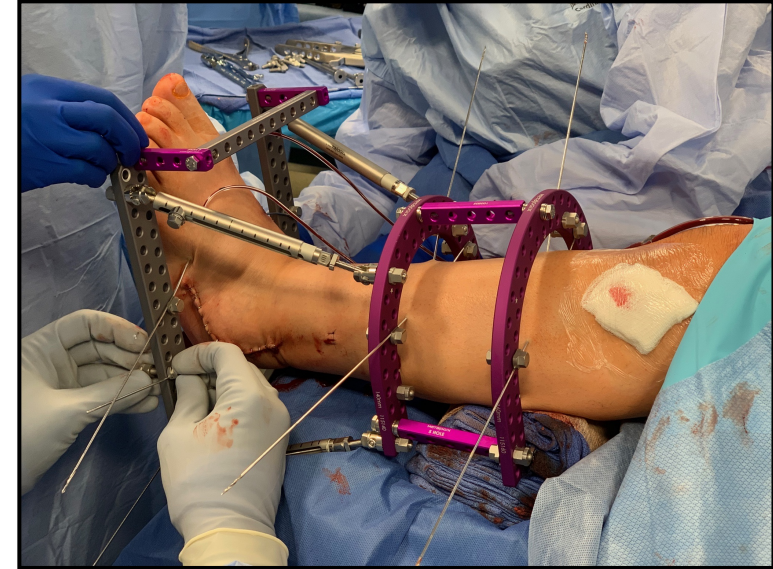
4

Remaining wires\* were inserted through the distal tibia and attached to the distal n-Plate, creating a very stable frame construct.

*\* All wires were attached with wire fixation bolts and spherical nuts.*

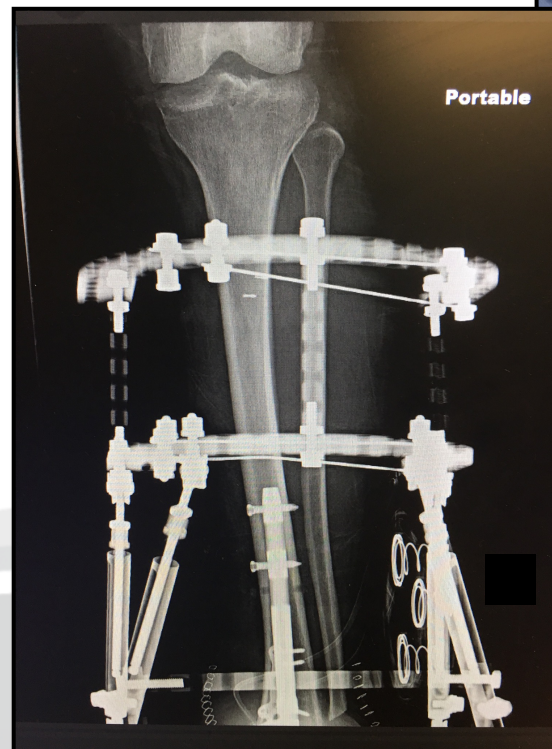
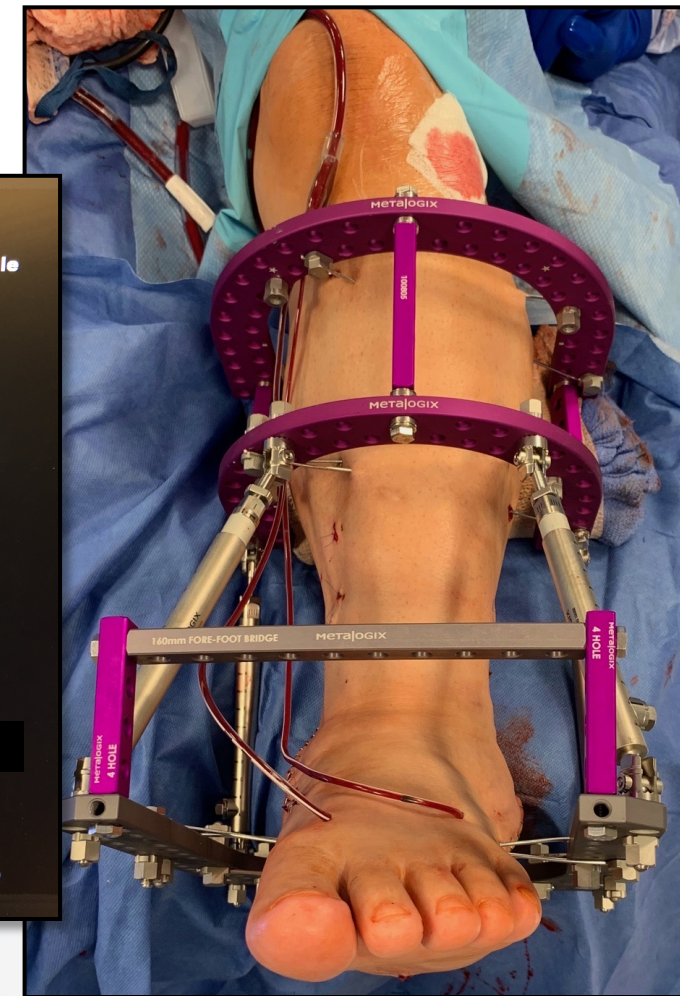
5

The surgical application of the Revolution Frame was straight-forward and successful. The open posterior plates allow for easy placement of the frame.

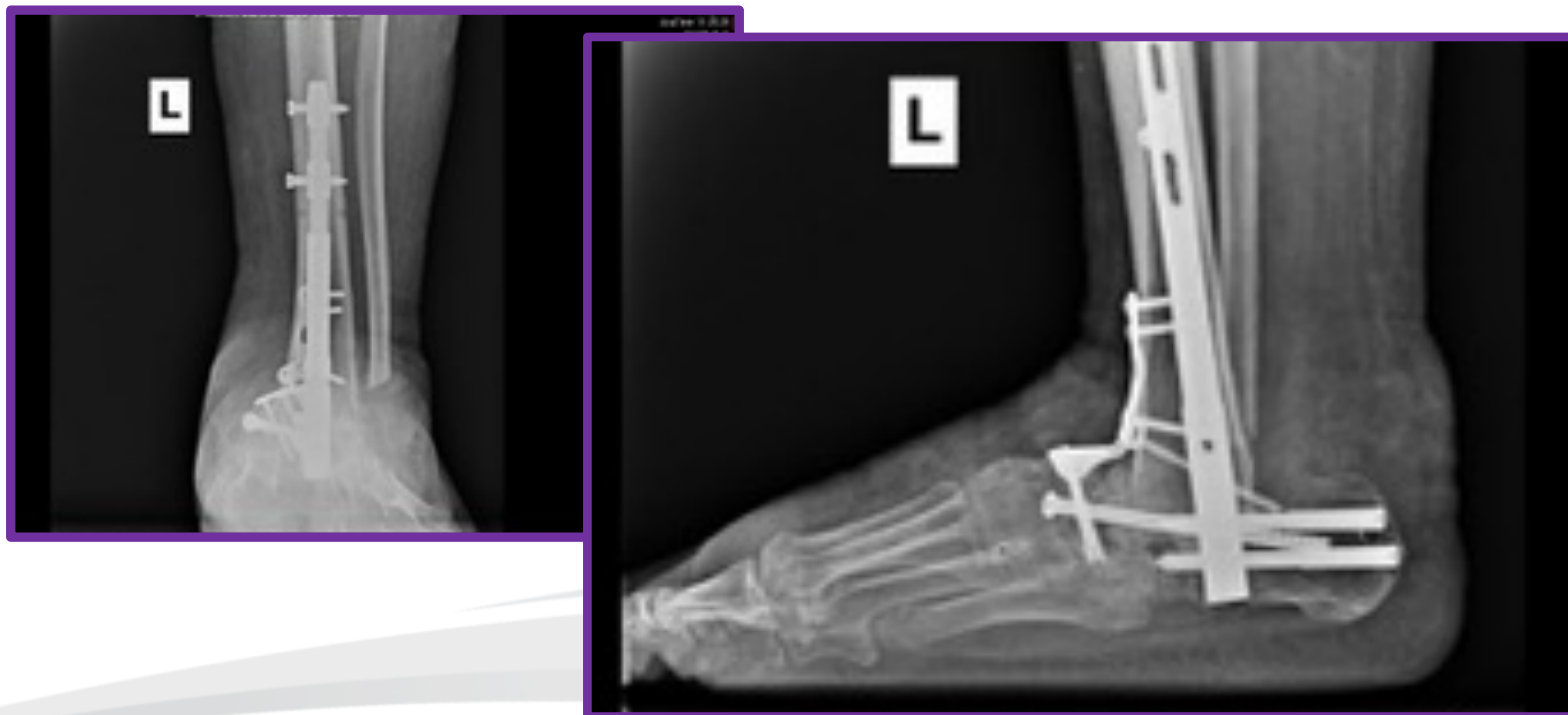
6

### POST-OPERATIVE

Frame was removed without issue on 08/08/2019. Patient is doing great and all fusion sites have healed.
